Manhole Inspection Summary

Manhole # S49MM_010MH

Insp Date: **5/13/08 8:37 AM**

Location Address: **Belair**

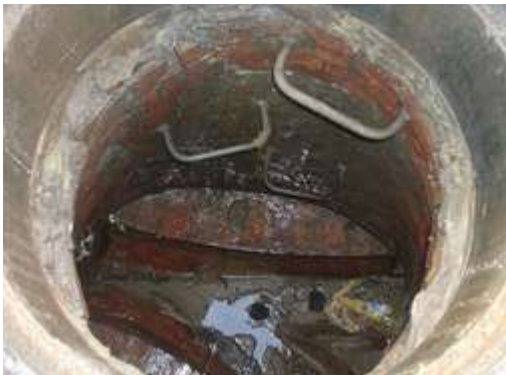
Defect 1

infiltration

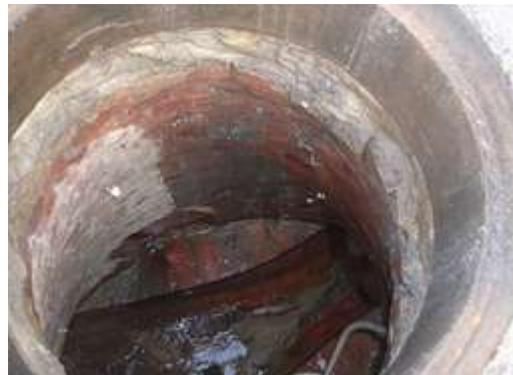
Defect 2

☒ **Leaks**

frame leaks

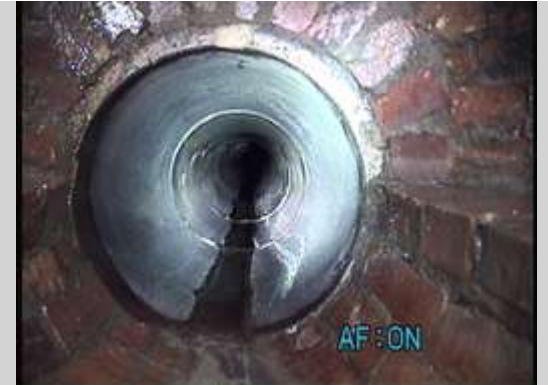
12 O'Clock Outflow

15 in. Circular Gravity Sewer
Pipe Out @ 12 O'Clock

Pipe Height: **15.6** (in.) Rod and Bar (Angled)
Pipe Material: **Clay** ☐ Pipe Lined
Invert Depth: **7.00** (ft.) Flow Characteristics: **Slow**
Deposits: ☒ None ☐ Mud ☐ Sludge ☐ Debris ☐ Grease
Silt Depth: (in.) Deposits Extent:
Infiltration: **None** Pipe Seal Cond: **Sound**

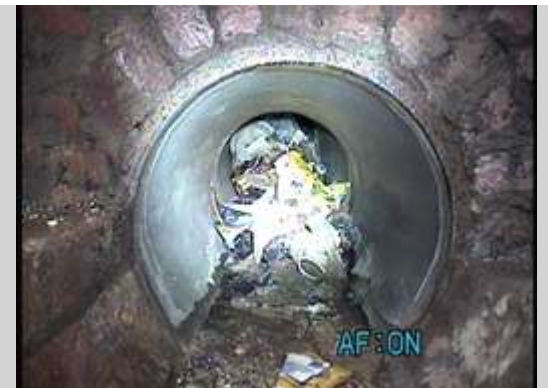
5 O'Clock Inflow

15 in. Circular Gravity Sewer
Pipe In @ 5 O'Clock

Pipe Height: **15.6** (in.) Rod and Bar (Angled)
Pipe Material: **Clay** ☐ Pipe Lined
Invert Depth: **7.05** (ft.) Flow Characteristics: **Slow**
Deposits: ☒ None ☐ Mud ☐ Sludge ☐ Debris ☐ Grease
Silt Depth: (in.) Deposits Extent:
Infiltration: **None** Pipe Seal Cond: **Sound**

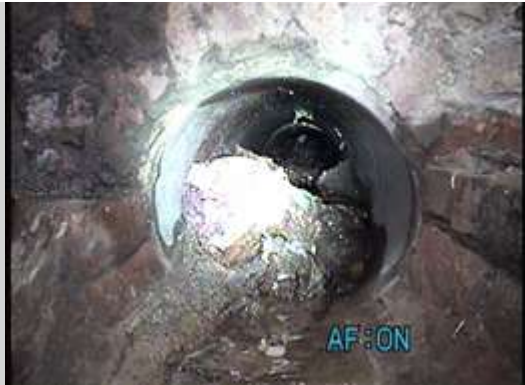
7 O'Clock Inflow

Pipe Height: **12** (in.) Rod and Bar (Angled)

Infiltration: **None**

Pipe Seal Cond: **Sound**

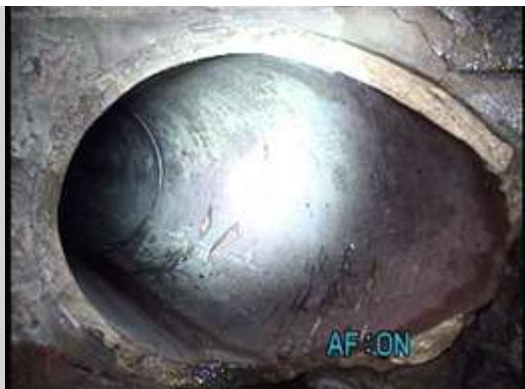
9 O'Clock Inflow

Pipe Height: **12** (in.) Rod and Bar (Angled)

Infiltration: **None**

Pipe Seal Cond: **Sound**
